JOURNAL OF THE TIMBER FRAMERS GUILD

Number 118, December 2015

Adaptive Reuse in Massachusetts

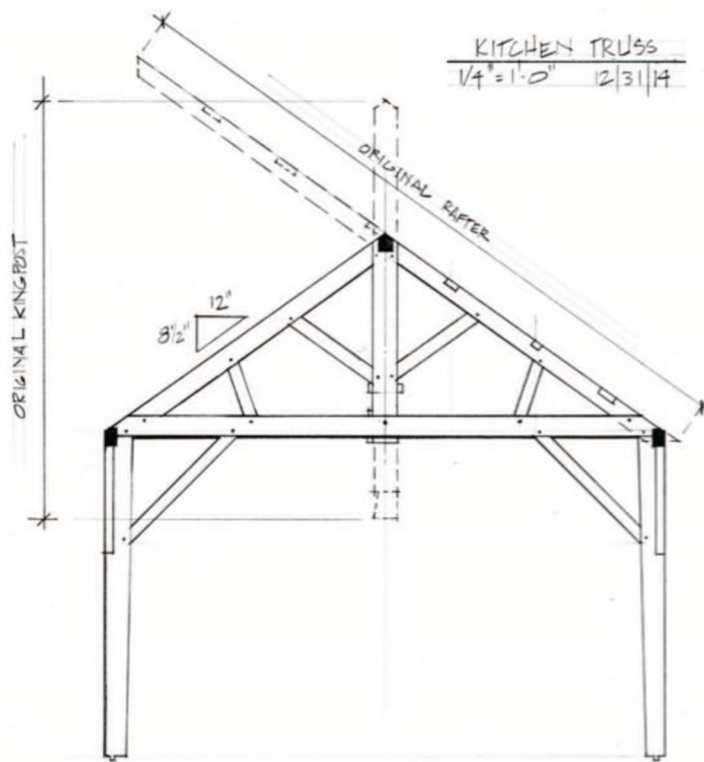
5 Above, original vs. adapted timber lengths.

While the frame was studied and documented in the shop, the company also had clients for whom a conceptually similar frame had been planned as a kitchen ell to be built with miscellaneous recycled barn parts. With the acquisition of the Maine barn frame, this space could be framed with recycled material from a single barn in nearly its original configuration, simply by attenuating the frame (Fig. 5). As in any adaptive reuse project, the capability of the old timbers had to be assessed.

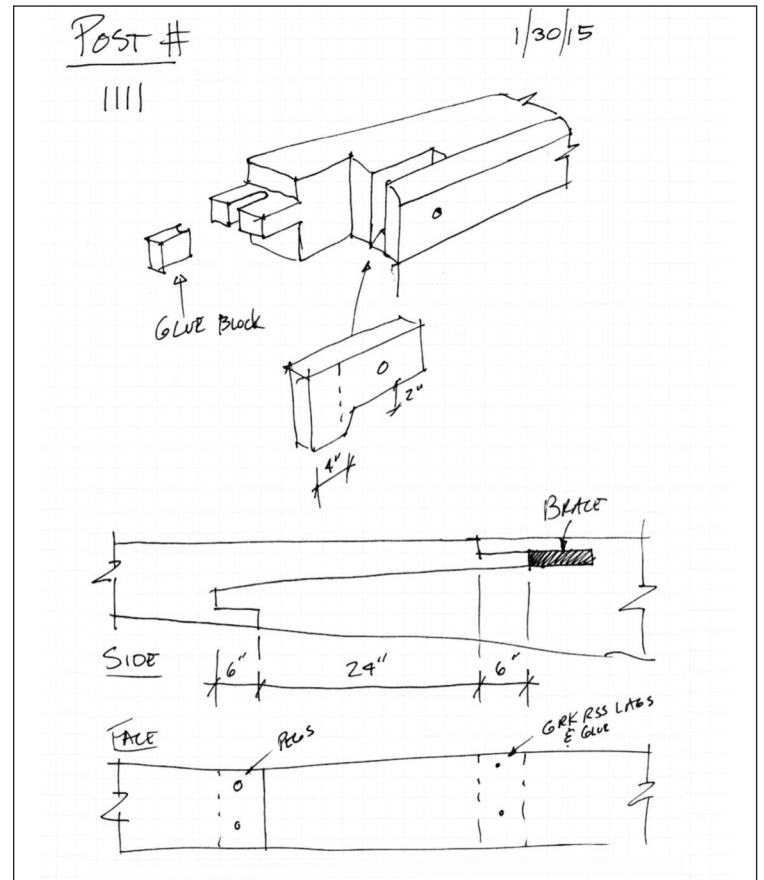
6 At right, working drawing for tying joint teazle tenon repair and plate tenon replacement, with scarfed addition to post.

structural repairs included filling peg holes in braces, correcting teazle tenon damage, replacing tenons, fitting short new post bottoms, and so on. Major structural repairs were required mostly in posts and tie beams, where 25 percent or more of the timber needed replacing. In these cases, the most important aspect of each timber was to save the portions that retained their original joinery, which would allow rescribing the frame. All the repairs were designed collaboratively with Jack Sobon to use traditional joinery and common historical practices (Fig. 6).

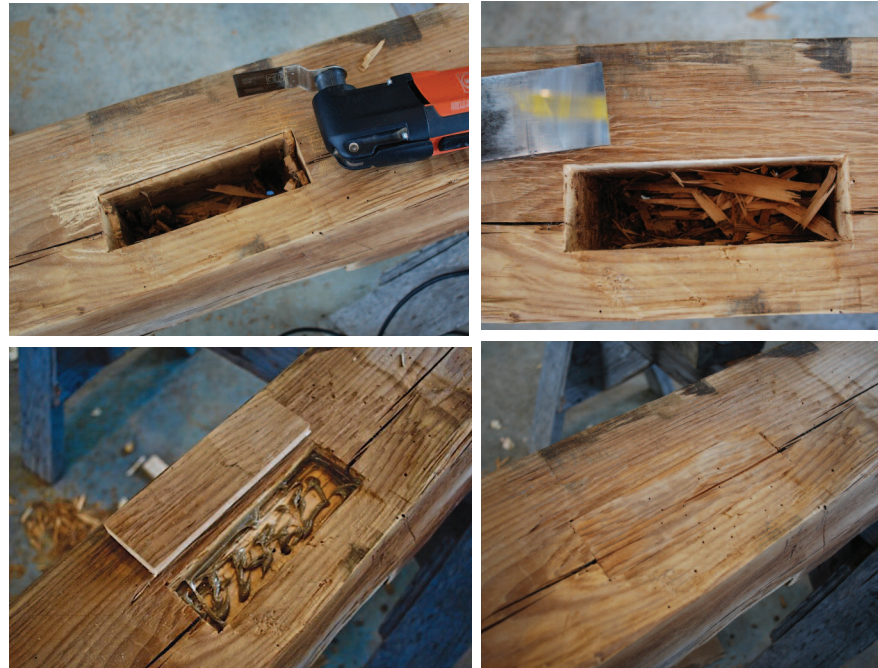
7 Partial sequence of patch prep after grain-match : a) trimming after knifing and roughing, b) deepening walls with framing chisel, c) setting filler block and glue, d) fitting patch.

Empty mortises were covered with face patches carefully selected from timbers with a similarly hewn finish. Once a patch was selected, the mortise would be recut to accept a face patch roughly 1/8-in. larger. First, a line was knifed around the mortise to describe its new size, then roughly cut with a chisel, trimmed plumb with a Fein tool as far as it would reach, and finally finished with a framing chisel.

With a filler block inserted into the mortise with polyurethane glue, a 1-in.-thick patch was then fitted on top to blend in with the existing face. All the timber's irregularities were accounted for in the process. If there was a slight bow or twist in the original hewn surface, saw kerfs were cut in the underside of the patch to within 1/8 in. of the top surface. This allowed the patch to conform to any uneven hewn surface, thus avoiding raised edges. If the timber surface showed historic holes from powderpost beetles, a scratch awl produced similar pock marks in the new face patch. Old chisel marks or scratches on scribed surfaces were replicated with the same tools to ensure a consistent surface.

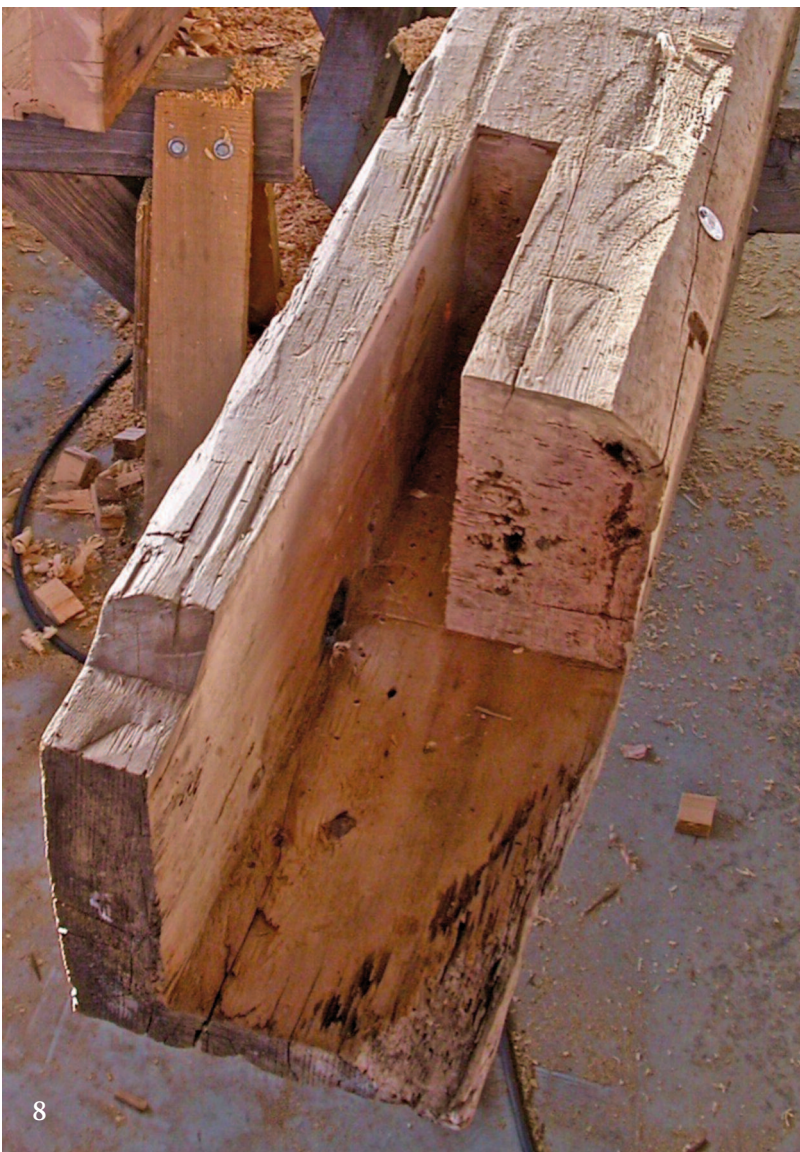
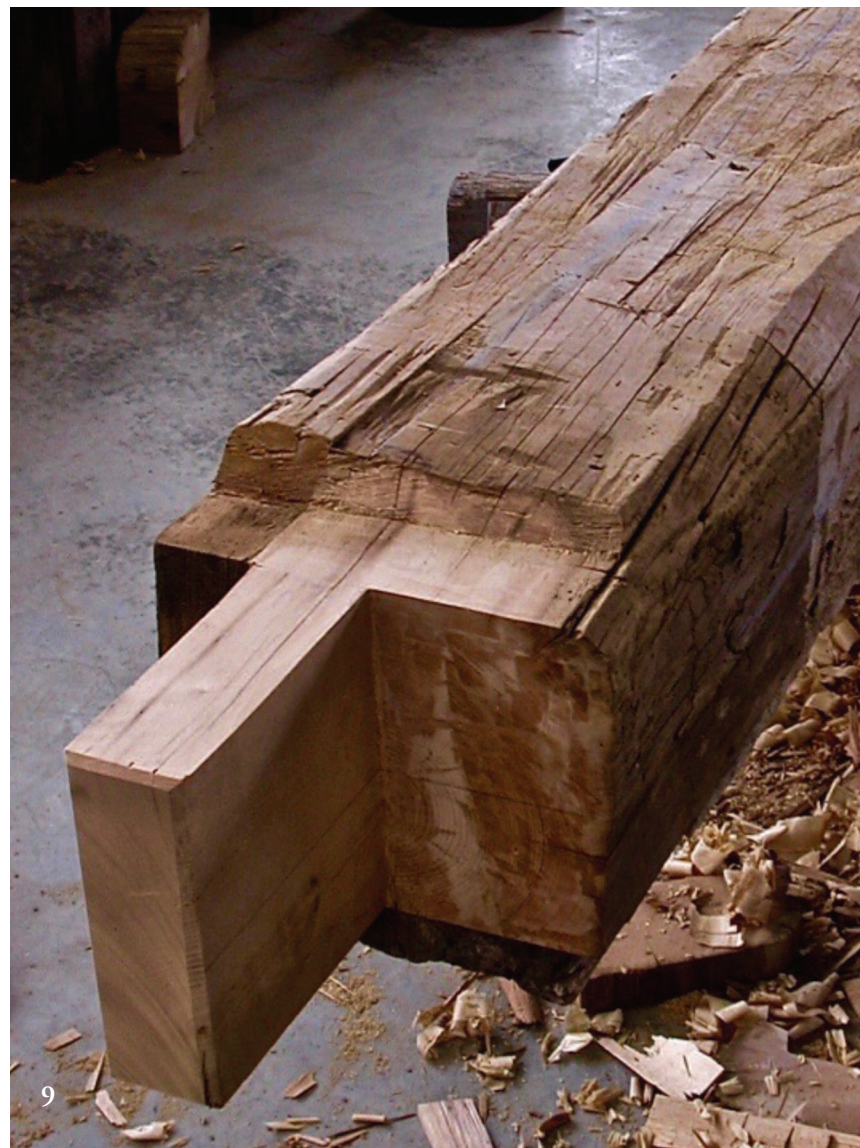
8, 9 New **bottom?** scarfed to **post?** (location?)

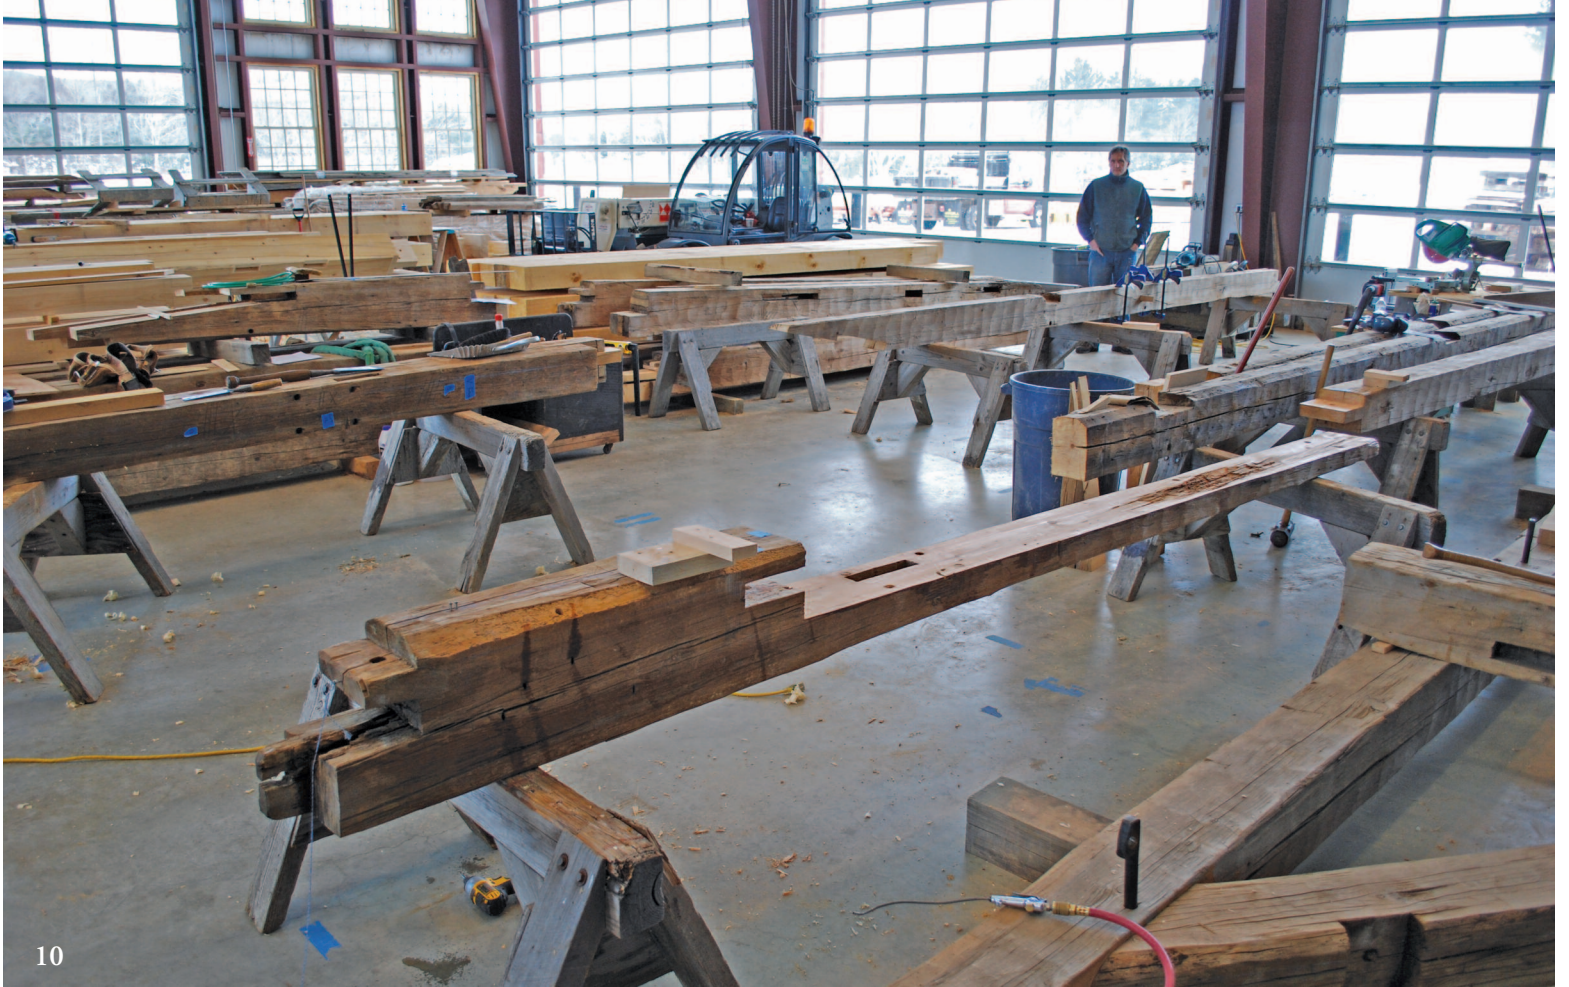
10

10–12 Major repairs, defined by 25 percent or more replacement material, sometimes reached 75 percent replacement material. Left above, **Xxxxx Yyyy** surveys repair work in progress. At left, **Vvvv Ttttt** measures for next timber insert.

dovetail joint, and so on. In some cases, more than 75 percent of a post would be replaced to preserve the top of the post and all of the joinery for the tying joint (Fig. 10). In one piece, over 6 ft. of rot was removed from a post and replaced with a resawn piece taken from a post elsewhere in the barn (Figs. 11-12). Others required scarf joints and pegs depending on their location and function. Unused tie beams and posts from the rest of the barn provided the stock for repairs or replacements (Fig. 13). As in the minor structural repairs, each piece had to be plumbed and leveled with snapped lines or later scribing (Fig. 14). Viewing even major repairs when completed, it would take a very keen eye to find the seams between the original and the repair material.

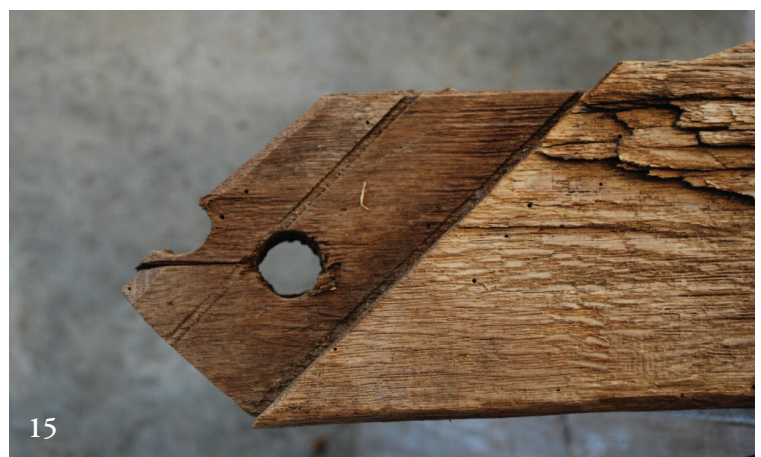
15 Shortened oak brace showing overcut line at original shoulder and remnant arc of original peg hole.

One intriguing discovery emerged when examining the riven white oak braces, dendrodated much earlier than the rest of the frame. Outboard of their existing shoulders, the tenons showed the overcut of an earlier sawn shoulder line and the tenon ends retained the arc of an earlier peg hole (Fig. 15), indicating that these braces had been used in a longer length before the building of the barn in Maine. So this is the third time that these oak braces have been used in a frame since the 18th century. —JAMES HESS
James Hess (artisanntimber@gmail.com), a recent graduate of the American College of the Building Arts in Charleston, S.C., works at David E. Lanoue, Inc., Stockbridge, Mass.
