God is in the Details

RESTORING THE HISTORIC GUTTERS AT THE 1829 NORTH FAMILY BRETHREN'S WORKSHOP

BY PETER A. WATSON, JR.

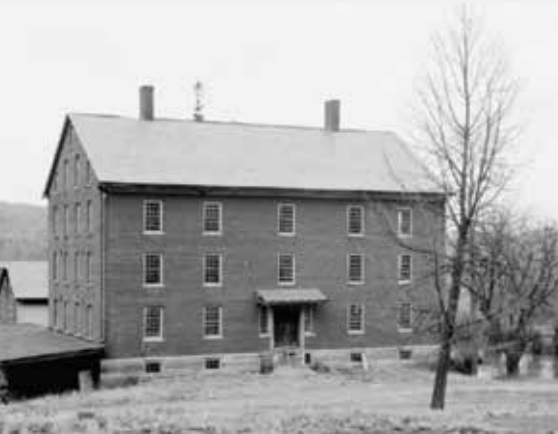
- FIG 1 Brethren's Workshop, east elevation, Historic American Building Survey (HABS, NY, II-Neleb. V, 31-1), (1939)
- FIG 2 Detail of circa 1888 photo showing Brethren's Workshop gutter and leader head. Collection of Shaker Museum | Mount Lebanon.

The six-story Brethren's Workshop is the oldest surviving structure at the North Family site and the only one constructed of brick [fig. 1]. It was the heart of manufacturing activities at the North Family and contained a waterwheel in the basement, fed by an above-ground sluiceway or penstock, that powered wood-working tools in the shop.⁵ The Brethren's Workshop also originally housed the Sister's laundry operation.⁶ Soon after the completion of the building, a Shaker journal noted, "1829, November 24 - the Sisters this day for the first time washed in the Brick Shop."⁷ The large new brick shop was sheltered by a relatively steep gabled roof, which provided a large surface area to collect rainwater. A metal gutter system fabricated of tin was installed on the east elevation of the structure, most likely as part of the original construction.⁸ A detail of a historic photo dating to the 1880s shows the original gutter system with its distinctive semi-cylindrical "leader heads [fig. 2]."

The Brethren's Workshop gutter system was probably connected to the large brick cistern that still exists in the basement although later building changes have obscured this relationship.⁹ Once installed, the Brethren's Workshop gutters remained in place for nearly one hundred and fifty years. The same gutter system appears in HABS photos taken in 1930s [see fig. 1] and is still intact in a photo from 1972 [fig. 3].¹⁰

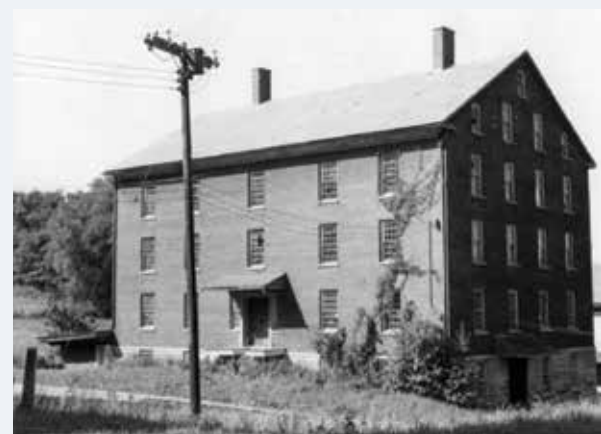
- FIG 3 East elevation of Brethren's Workshop showing intact leader heads, circa 1972. Photo: James Baker, Architect of Record for the Darrow School.
- FIG 4 Built-in gutter carved from a single log, circa 1799, New York State, collection of Don Carpentier, Eastfield Village. Photo: Peter Watson.

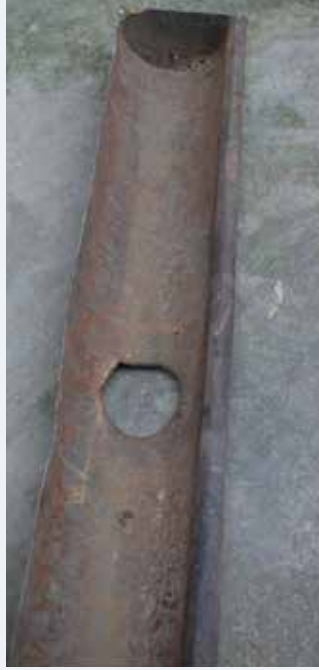
- FIG 5 Section of tin gutter, circa early 1800s, New York State, collection of Don Carpentier, Eastfield Village. Photo: Peter Watson.
- FIG 6 South elevation of North Family Sisters Second Dwelling, Historic American Buildings Survey (HABS NY,11-NELEB.V,25-3), circa 1930.

The earliest gutters and downspouts used in the North American colonies were wholly made of wood.¹¹ By the time of the Revolution, however, public buildings and finer residences in major cities began to be outfitted with imported metal gutter components made of lead. By 1800, lead gutter components were increasingly replaced with more economical tin (tin-coated iron) or terne (lead and tin-coated iron) components built up from sheet metal. In the New York State and other parts of the Northeast, it was common to use a mix of tin and wood elements. A typical early nineteenth century arrangement was to employ a wood “built-in gutter” that had been carved out of a single log [fig. 4] with a tin leader head and downspout on the front of the house, and a simpler “attached” tin “half-round” gutter [fig. 5] and downspout on the less important rear elevation.¹²

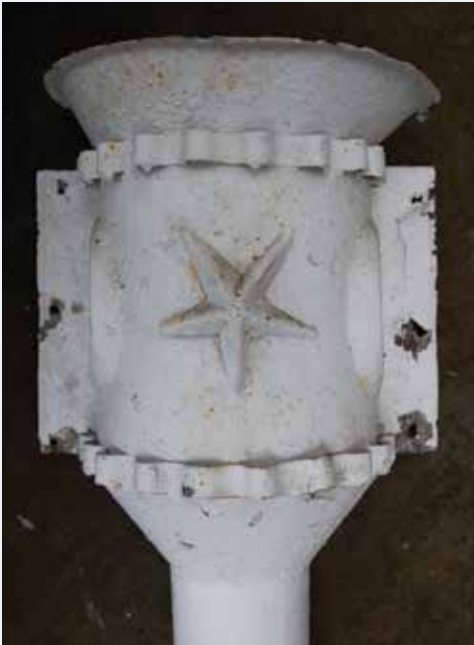
- FIG 7 Tin leader head, circa 1815, from Eagle Mills, New York. Collection of Don Carpentier, Eastfield Village. Photo: Peter Watson.
- FIG 8 Circa 1868 photo showing tin leader heads on a row of commercial structures, Front Street, South of Dock, Philadelphia. Collection Free Library of Philadelphia.

at the Brethren’s Workshop replicates a relatively common early nineteenth century form in New York State.¹³ Fig. 7 shows a circa 1815 example from Eagle Mills, New York in the collection of Don Carpentier that is virtually identical to the Brethren’s Workshop leader head minus the decorative elements. Fig. 8 shows another undecorated example in-situ on a group of commercial structures in Philadelphia.

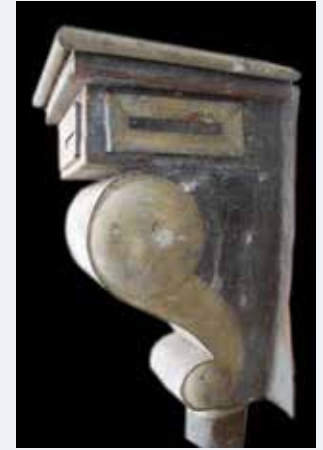
- FIG 9 Painted scroll form tin leader head, circa 1840, collection of Don Carpentier, Eastfield Village. Photo: Peter Watson.
- FIG 10 Jared Lodge cutting down lead-coated copper sheeting to period 10 x 14 inch dimensions. Photo: Peter Smith.

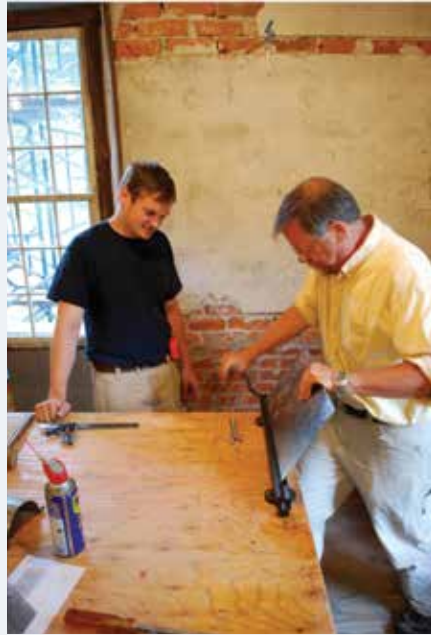
- FIG 11 William Burns watches Don Carpentier rolling the lip of the gutter section using a gutter beader. Photo: Peter Smith.
- FIG 12 Using a slip roller to round the gutter section. Photo: Peter Smith.

The gutter pan forms were then built up around wood molds in a series of operations using period tools.¹⁵ First, the inner lip of the gutter was doubled by making a 3/8 inch fold with a "bar folder". Next, the outer lip of the gutter section was created by rolling the edge of the sheet into a tight tube using a "gutter beader" [fig. 11]. This stiffened the gutter section up and provided an anchor to attach the front of the gutter hook. Next, the gutter section was turned over and rounded into the desired half-round profile using a "slip roller" [fig. 12]. The completed sections were then laid on a wood "gutter form" [fig. 13], where they were soldered together [fig. 14]. The 14-inch long sections were built up into two large sections spanning the entire fifty-four foot width of the building.¹⁶

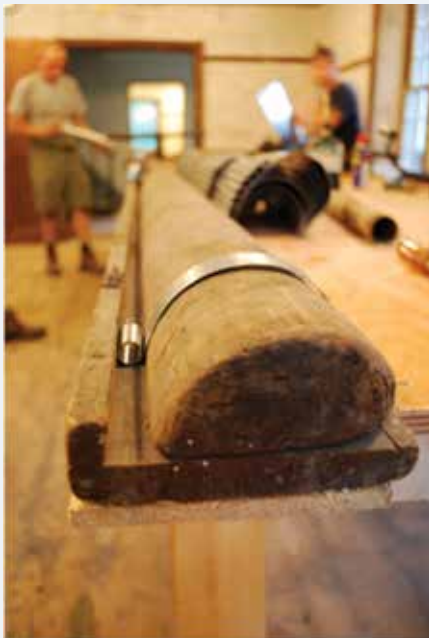
- FIG 13 Laying the gutter sections on the gutter form in preparation for soldering. Photo: Peter Smith.
- FIG 14 Mike Fountain soldering the gutter sections together. Photo: Peter Smith.

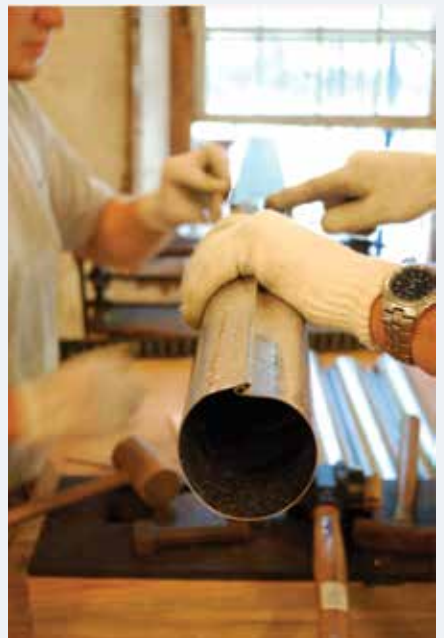
FIG15

- FIG 15 Locking the seam on the leader pipe section. Photo: Peter Smith.
- FIG 16 Don Carpentier flattening the lock seam with a hammer. Photo: Peter Smith.

The construction of the leader pipe also began with a full sheet laid lengthwise. The edges of sheet were turned up and folded over using a bar folder, in opposite directions, to form a “lock seam.” The sheet was then rounded into a tubular form using the slip roller and the seam locked together [fig. 15]. Next, the leader pipe section was placed on a “conductor stake” and the lock seam was flattened down with a hammer to lock it tight [fig. 16]. The seam was finished with a “grooving tool” and soldered to further reinforce it [fig. 17]. The upper part of each section was then flared outward on a “beak horn stake” to allow the parts to fit together [fig. 18].³⁷ The completed sections of leader pipe were then assembled [fig. 19] and soldered together to form the desired length for the installation.

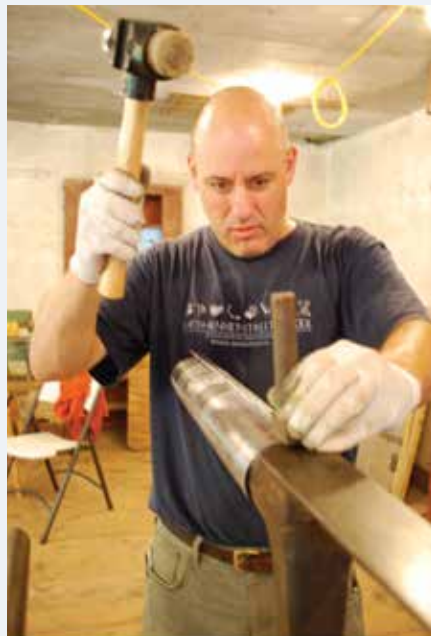
FIG17

- FIG 17 Frank DiFrancesco using a grooving tool to finish the seam. Photo: Peter Smith.
- FIG 18 Jared Lodge flaring the top of the leader pipe section on the conductor stake. Photo: Peter Smith.

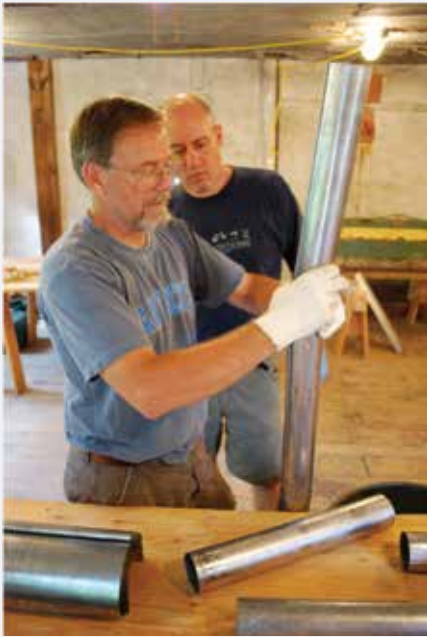
- FIG 19 Assembling the leader pipe sections in preparation for soldering. Photo: Peter Smith.
- FIG 20 Don Carpentier using a square pan swedge to crease the back of the leader head. Photo: Peter Smith.

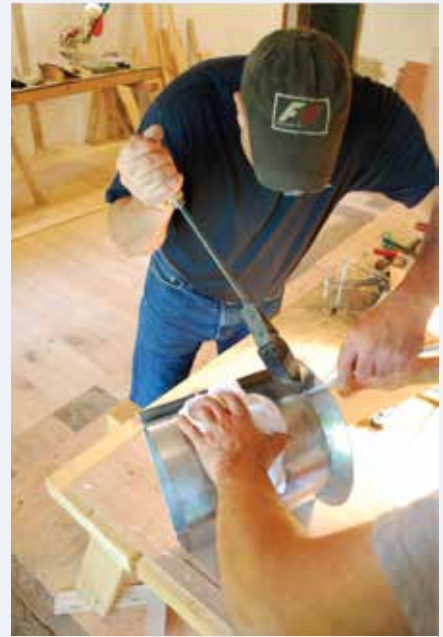
- FIG 21 Soldering the top rim onto the basin of the leader head. Photo: Peter Smith.
- FIG 22 Don Carpentier forming the bottom funnel. Photo: Peter Smith.

create a raised edge to receive the top rim which was then cut out and soldered in place [fig. 21]. The bottom funnel was then cut out, and the edges overlapped and soldered together. Next, the funnel was soldered to the bottom of the basin that had also been prepared with the burring machine [fig. 22]. Lastly, a section of leader pipe was soldered onto the end of the funnel [fig. 23]. Fig. 24 shows the completed unit, which represents what is probably the first leader head made for a Shaker building since 1829 when the Brethren’s Workshop was finished.

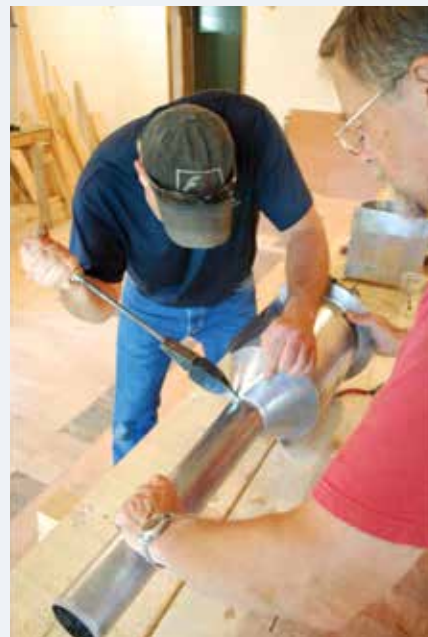
- FIG 23 Soldering a section of leader pipe onto the leader head. Photo: Peter Smith.
- FIG 24 The completed leader head, ready to be primed and painted. Photo: Peter Smith.

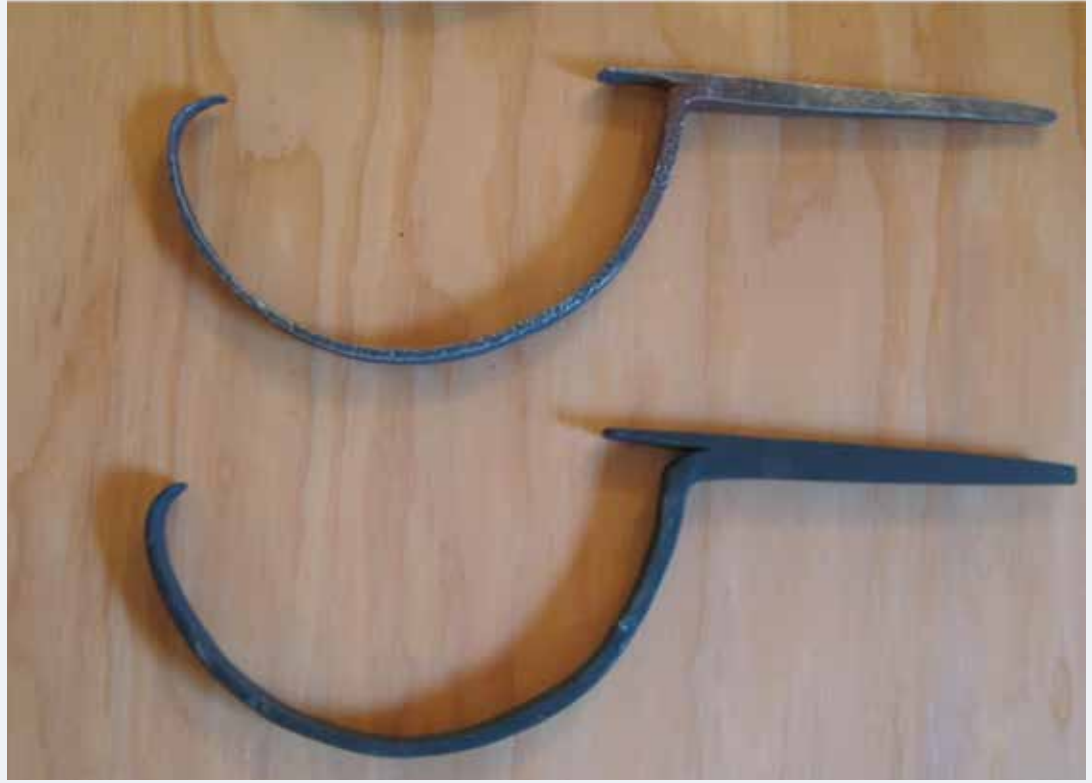
- FIG 25 Original (top) and reproduction (bottom) Shaker gutter hooks. Photo: Jerry Grant.
- FIG 26 Restored gutters on the east elevation of the Brethren's Workshop. Photo: Peter Watson.

Several of the original wrought iron gutter hooks were still in place below the roof eave allowing them to be replicated by Michael J. Saari, a blacksmith from Woodstock, Connecticut [fig. 25]. The design of these gutter hooks is, according to Don Carpentier, “very unique” and represents the practical Shaker aesthetic at work. Rather than the typical worldly design which required an additional cross piece or “gutter strap” connecting the outer edge of the gutter lip with the adjoining roof eave to prevent the gutter being knocked out of place by high winds, the North Family Shakers invented a simpler and more elegant solution. The Shakers added a spur to back edge of the gutter hook to hold the rear of the gutter pan and curved the front inward to form a spring that snugly locked the gutter in place. The resulting gutter hook is both more sculptural and more effective than worldly designs of the period.

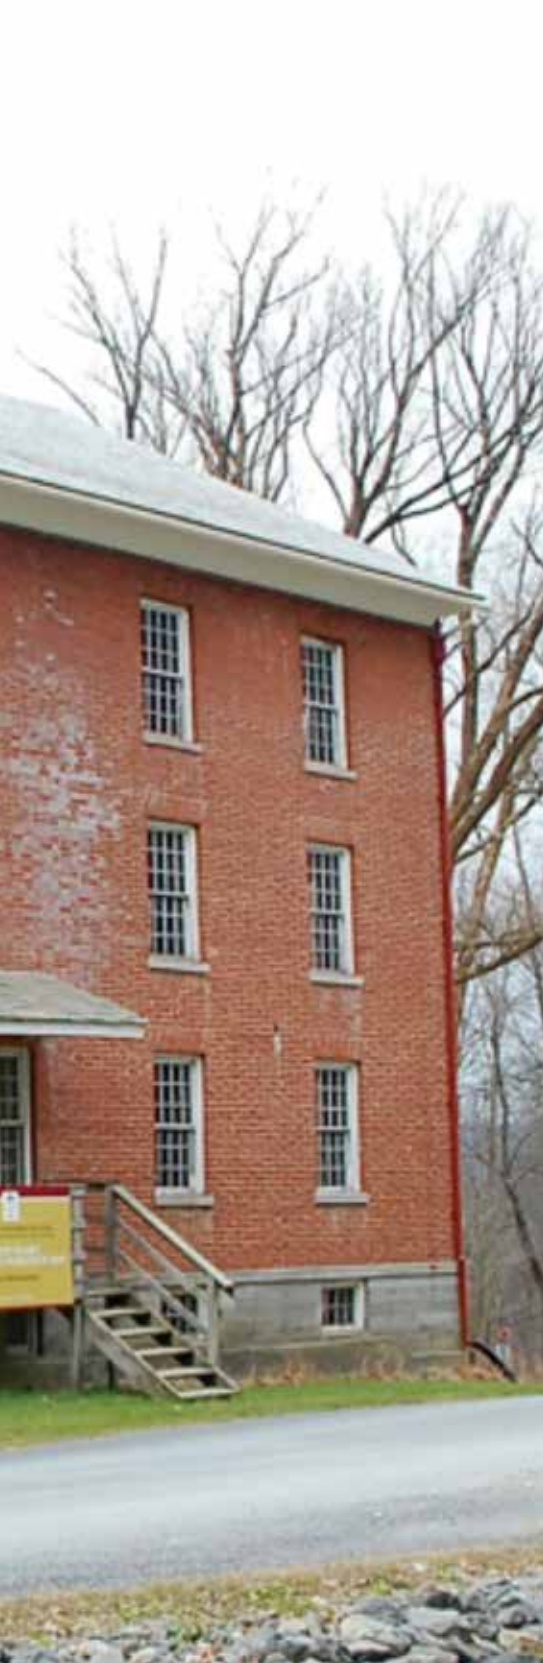
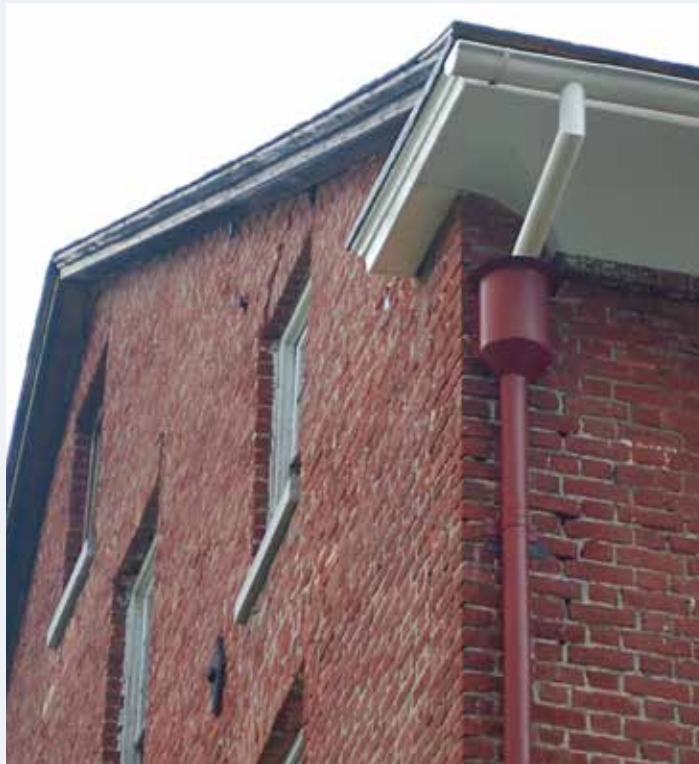
- FIG 27 Detail of restored gutters. Photo: Peter Watson.

Figs. 26 and 27 show the completed Brethren's Workshop gutter installation. Before being attached to the building, all of the gutter components were primed and then painted with a handmade linseed oil paint ground in a paint mill replicating the period treatment. Following historic photos, the gutter was painted white to match the restored plaster cove molding and the leader head

and leader pipe painted red to match the main body of the building which paint analysis had showed to have been originally painted a similar color. The restoration of the gutters at the Brethren's Workshop amply demonstrates that for the Shakers, and committed museums and historic sites that seek to interpret and honor this heritage, "God is in the details."
