JOURNAL OF THE TIMBER FRAMERS GUILD

Number 118, December 2015

Adaptive Reuse in Massachusetts

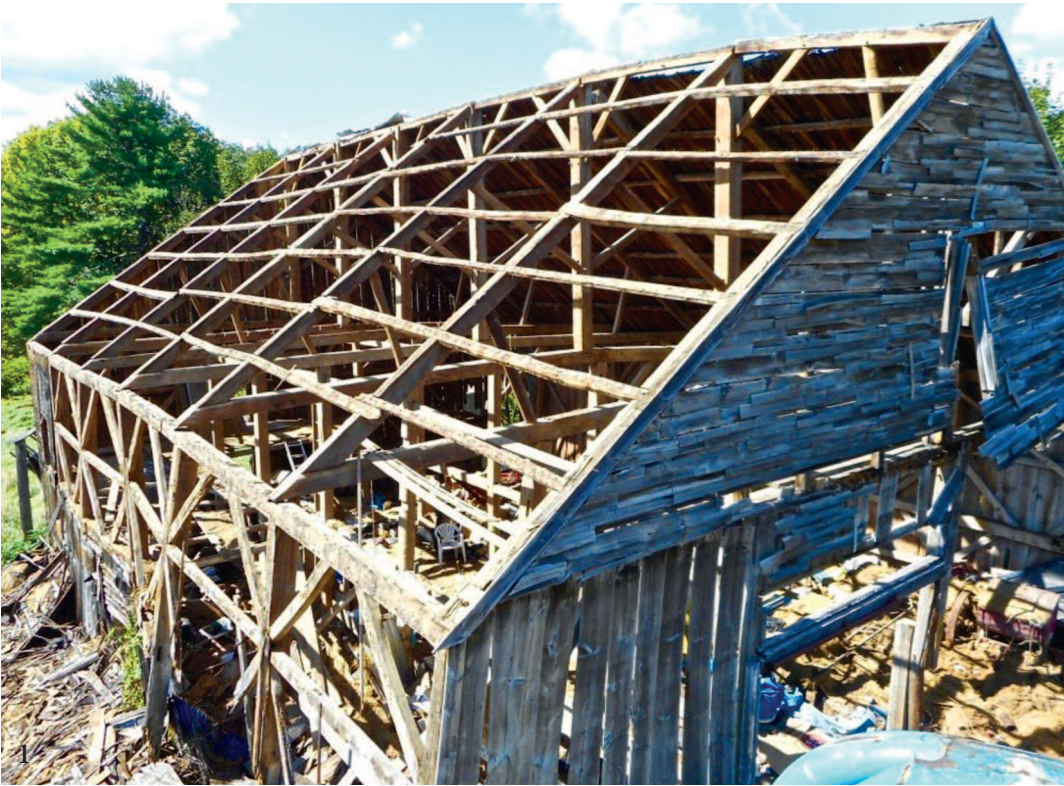
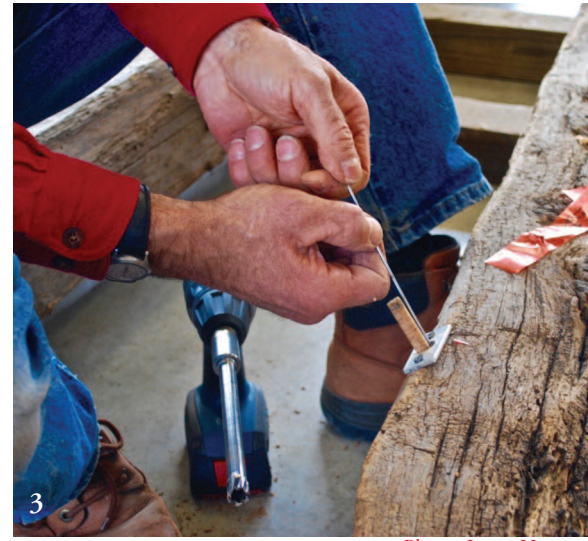
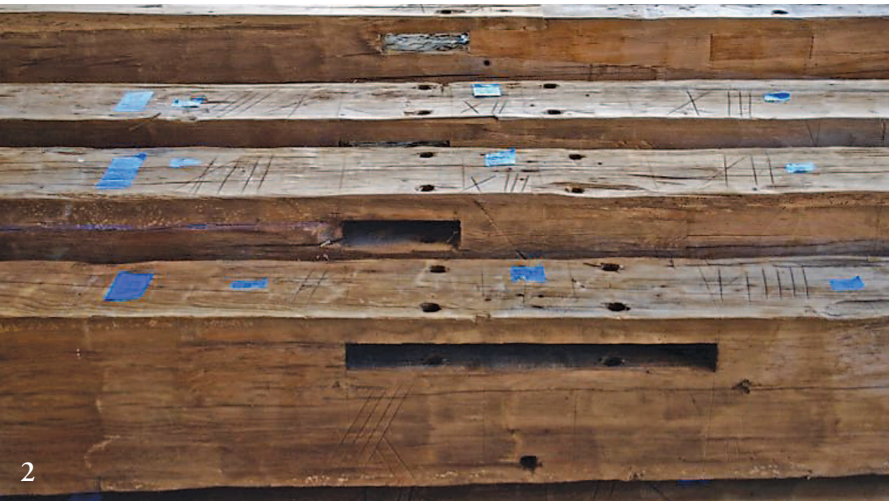
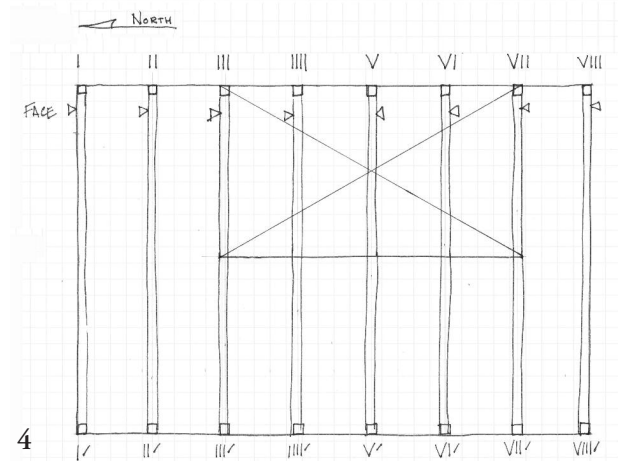
- 1 Barn frame as it stood in 2014 in Alfred, Me., built ca. 1802.
- 2 Timbers in shop for assessment.
- 3 Extracting core for dendrodating.
- 4 Proportion of frame to be reused.

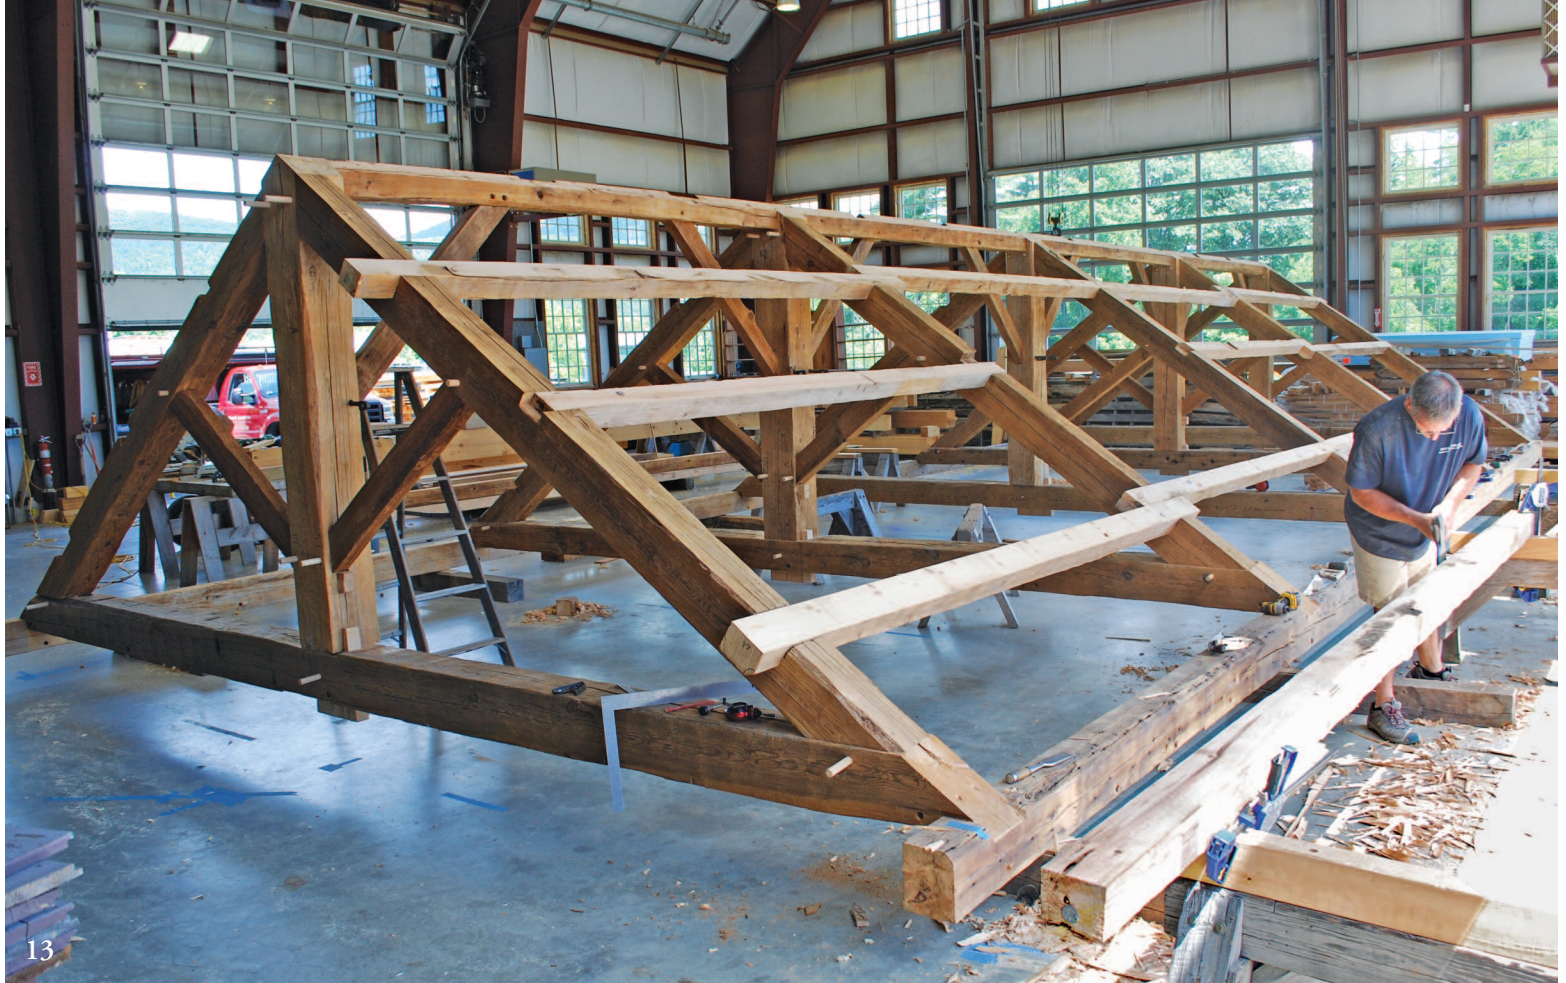
13

10–12 Major repairs, defined by 25 percent or more replacement material, sometimes reached 75 percent replacement material. Left above, **Xxxxx Yyyy** surveys repair work in progress. At left, **Vvvv Ttttt** measures for next timber insert.

dovetail joint, and so on. In some cases, more than 75 percent of a post would be replaced to preserve the top of the post and all of the joinery for the tying joint (Fig. 10). In one piece, over 6 ft. of rot was removed from a post and replaced with a resawn piece taken from a post elsewhere in the barn (Figs. 11-12). Others required scarf joints and pegs depending on their location and function. Unused tie beams and posts from the rest of the barn provided the stock for repairs or replacements (Fig. 13). As in the minor structural repairs, each piece had to be plumbed and leveled with snapped lines or later scribing (Fig. 14). Viewing even major repairs when completed, it would take a very keen eye to find the seams between the original and the repair material.

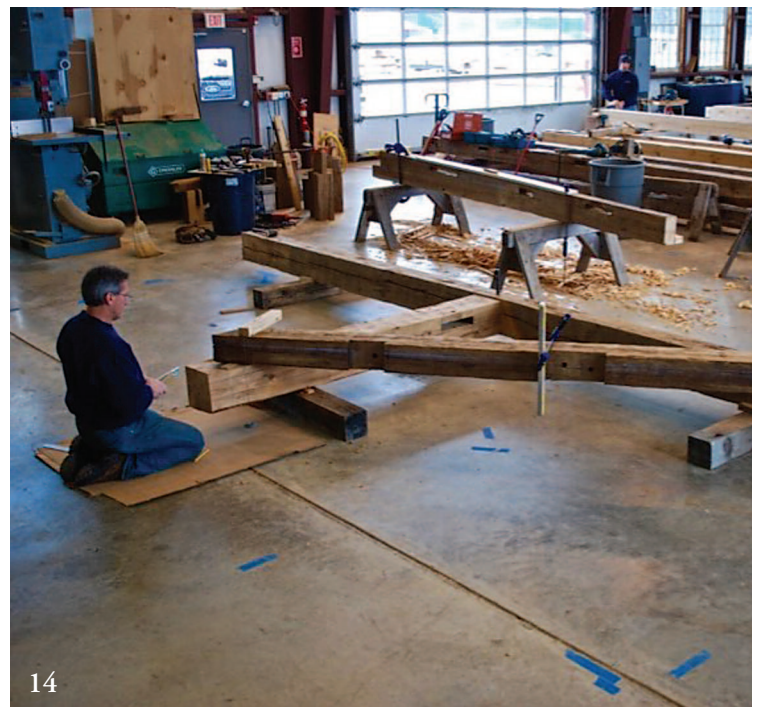
14 **Ttttt Rrrrr** scribes shortened rafter to kingpost.
